SHIP AHOY MARINA

Marine Assessment

Prepared by: JSS Consulting

Date: September 2022

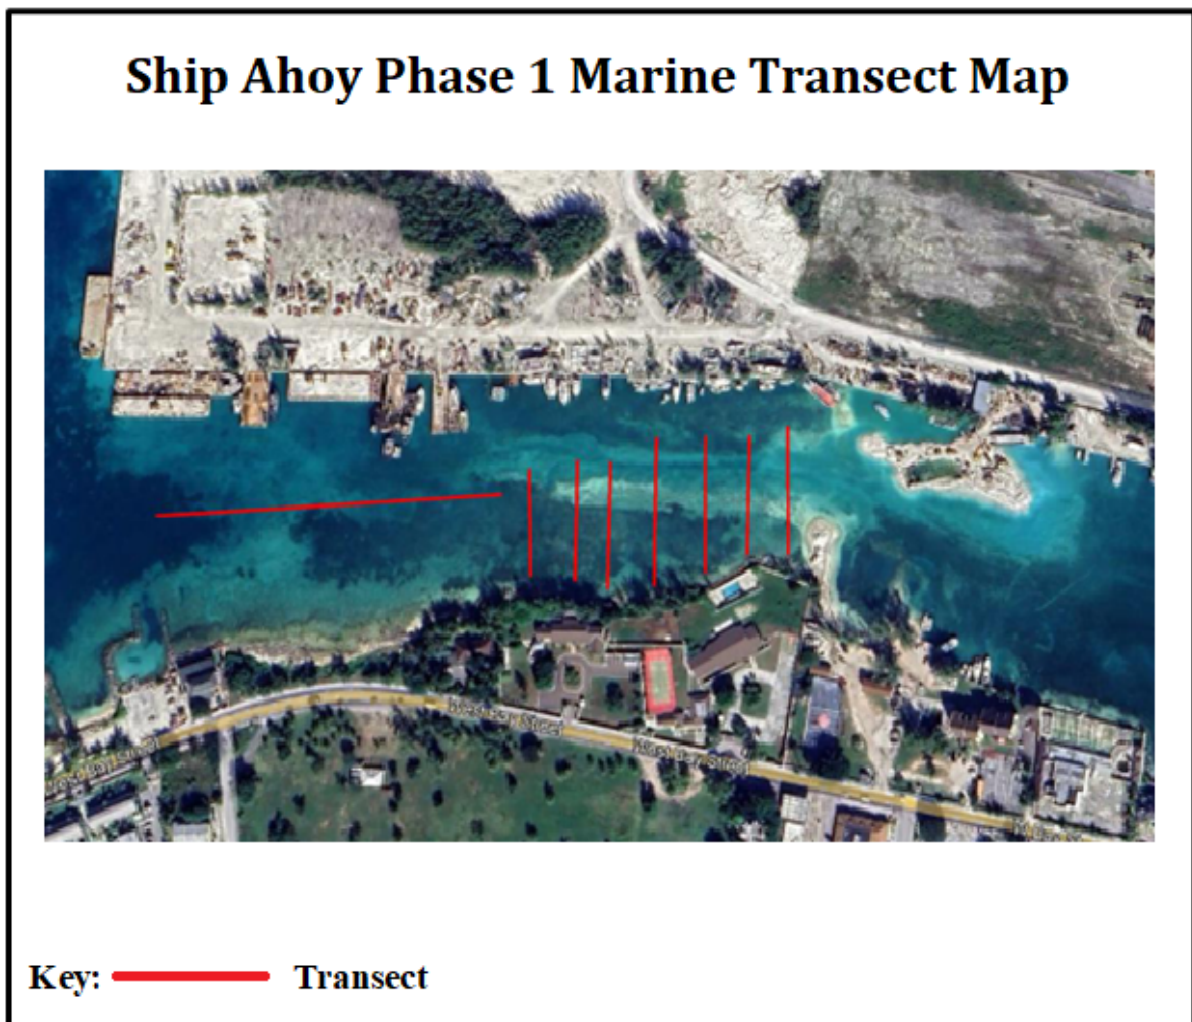
Line transects perpendicular to the property were performed in the proposed work area (See figure 2). Smaller transects perpendicular to the property were done in the channel area (depicted by the horizontal line). These smaller transects will be combined into one transect due to the small area and the similar benthic profile. The substrate type, fauna, and flora species were identified and recorded during this assessment. General observations were also made for the surveyed area. A record was taken of all flora, fauna and substrate types encountered during the survey. Species abundance was recorded as Single (1), Few (2-9) and Many (10+).

Figure 2: Marine Transect Map of Project Area

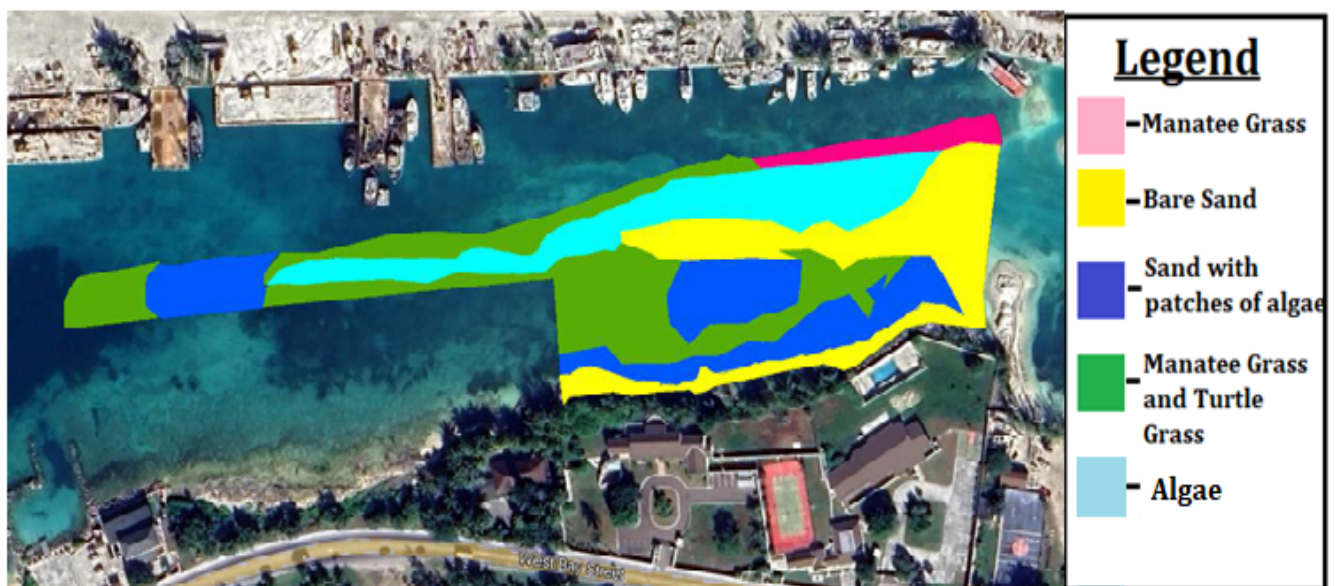
The benthic composition transitions between Manatee grass and Turtle grass, manatee grass, algae (Halimeda Sp. and Rhodophyta Sp.), and sand. Figure 3 & 4 illustrates the transition of the benthic substrate of the property. The predominant epifauna observed was Upside Down Jellyfish (*Cassiopea xamachana*).

Figure 3: Habitat Map

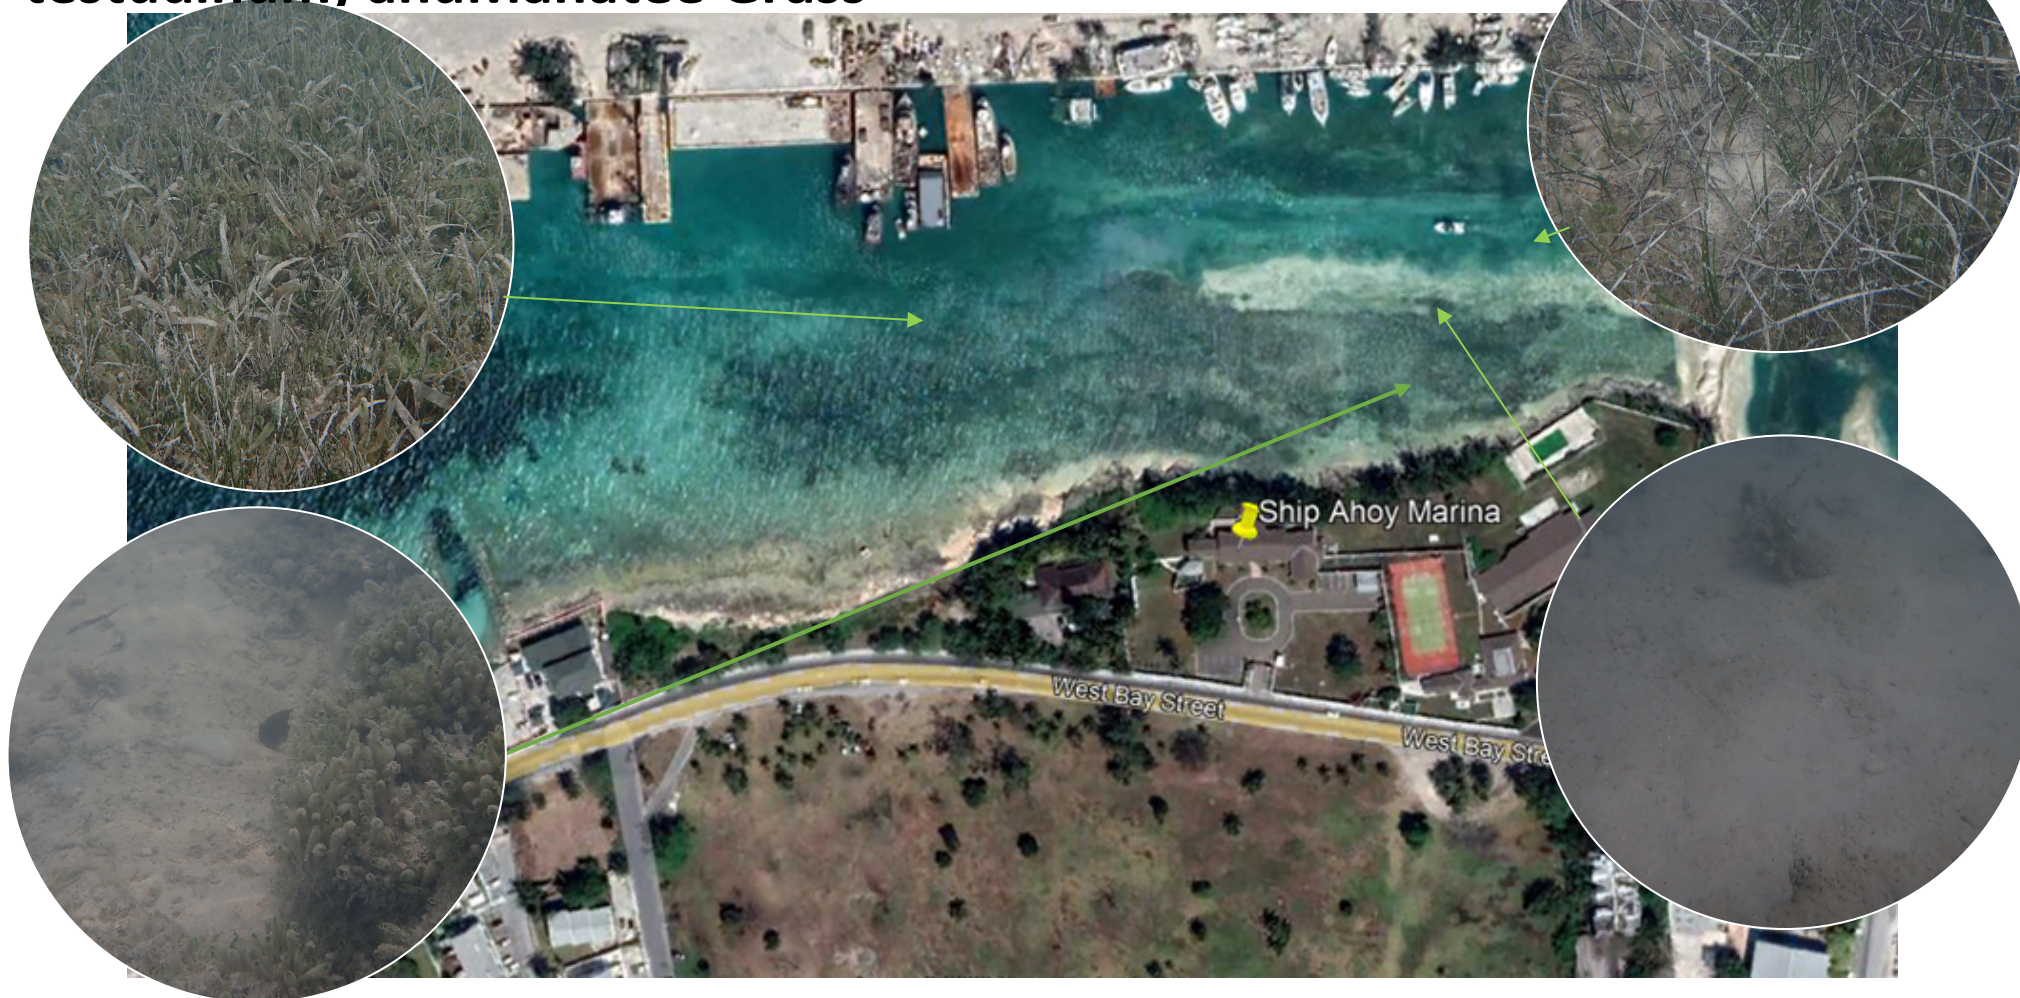
Benthic Profile
(Figure 4)

Manatee Grass

Sand with Patch of
Algae

Bare Sand

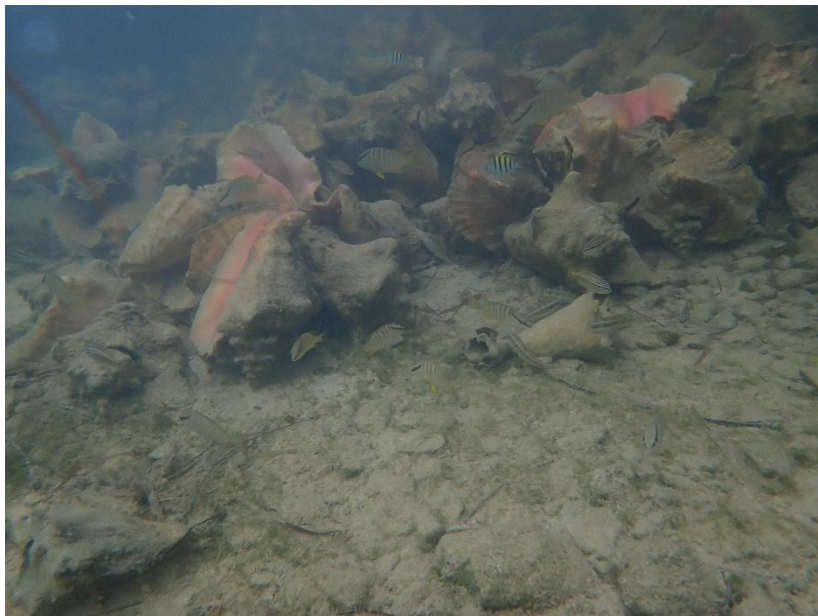
Non-coral Invertebrate diversity was moderate while the abundance was low across the entire site. Along the shoreline of Transect 7 a pile of Queen Conch shells (See photo 6) was observed suggesting this area may have previously been a dumping ground for Queen Conch shells. Algae diversity was moderate, but the abundance was high across the entire assessment site.

Photo 6: Pile of Conch shells
